Hanford Corrosion Testing at CC Technologies

Colin Scott, Feng Gui and Sean Brossia
CC Technologies / DNV Columbus.

High-Level Waste Tank Integrity Workshop
May 2008

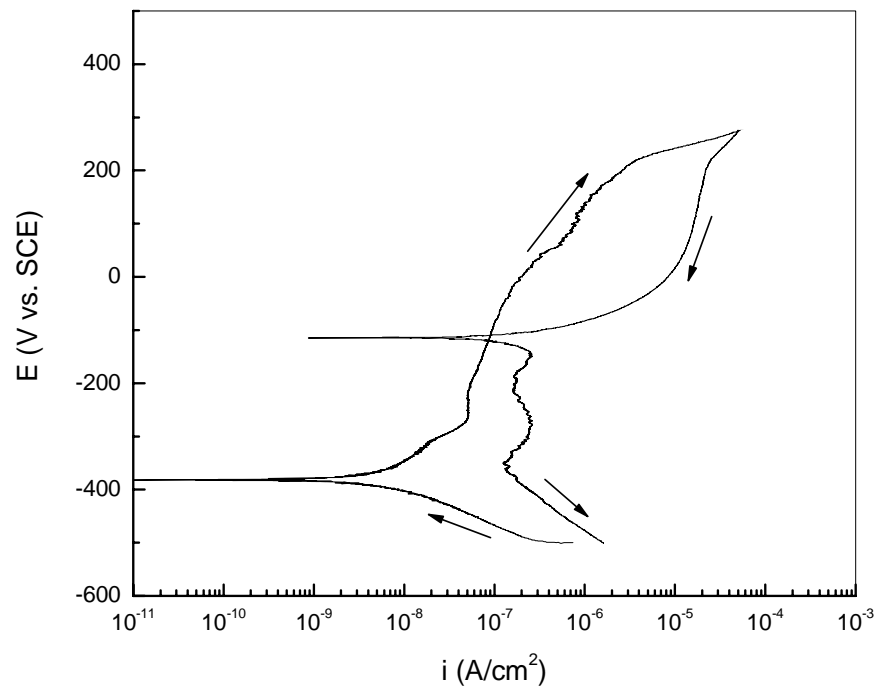
- AN107 (high nitrate and nitrite)
- Hysteresis loop and pitting observed

- Steel is susceptible to pitting corrosion in AN107 simulant but not in other simulants
- Active-passive transition noted on the CPP curve in AY102-PIL simulant. Carbonate induced SCC is likely near the transition region
- Interfacial corrosion observed in AP105-PSC test at elevated temperatures, investigation in progress.

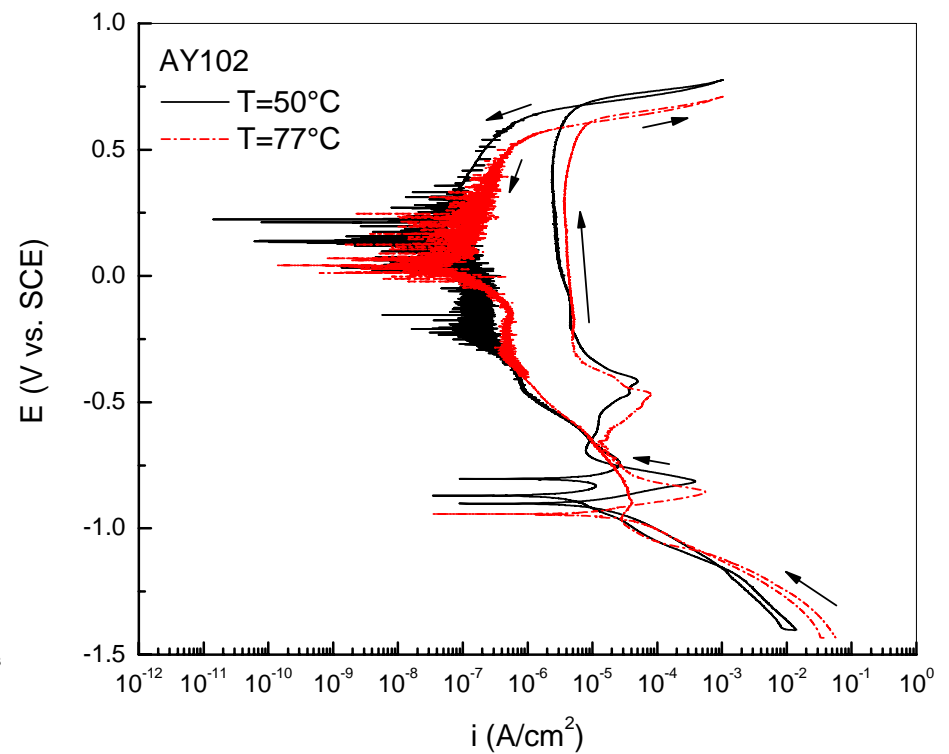
- AY102-PIL (high carbonate)
- Active-passive transition

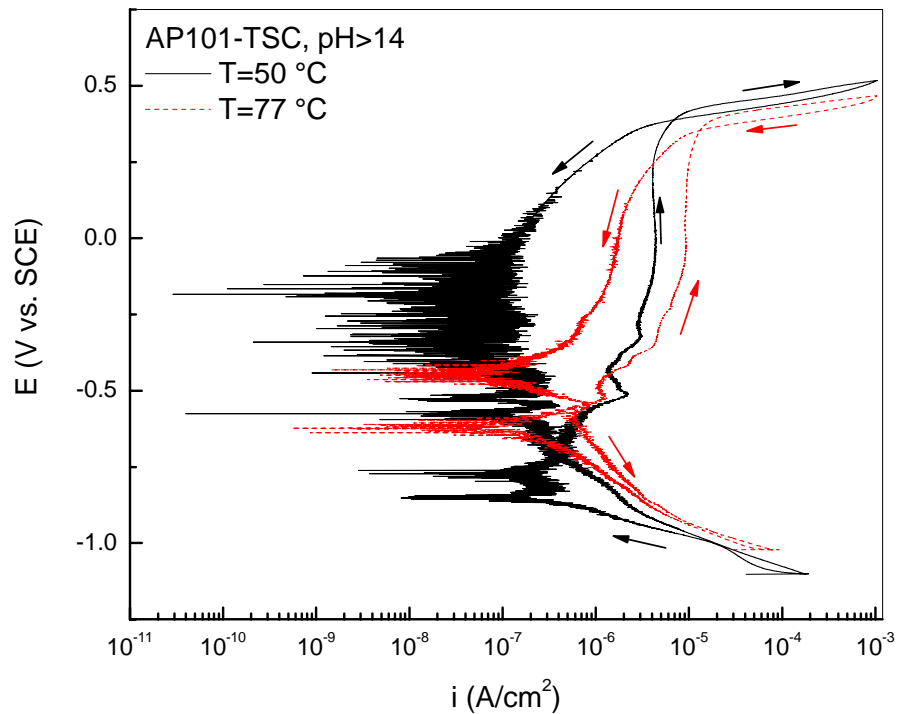
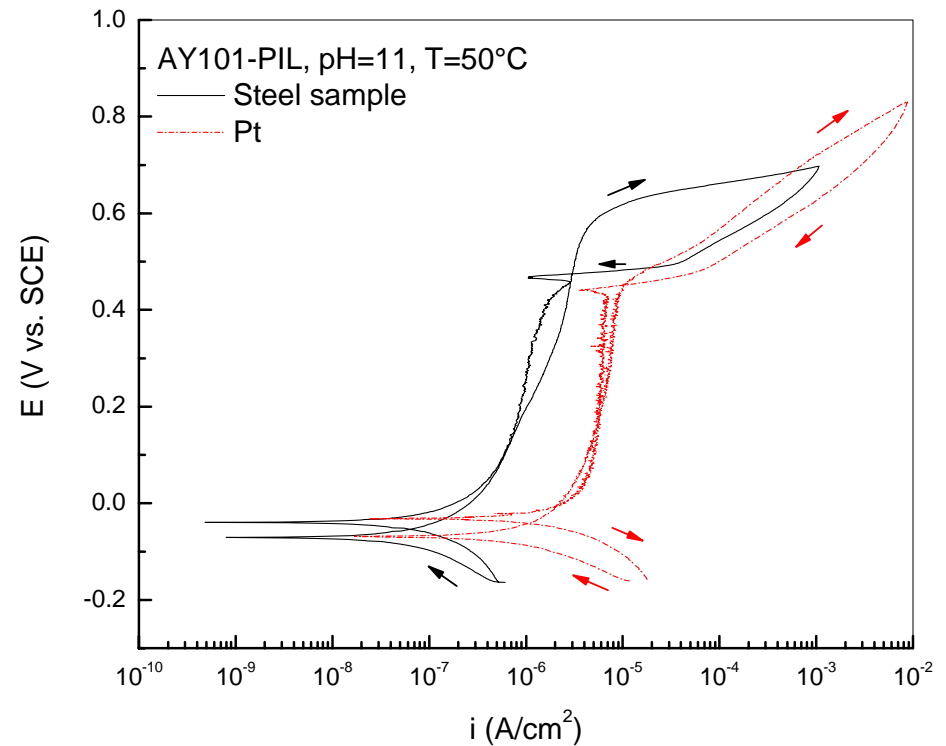
CPP of AP101 and AY101

- AP101-TSC (high nitrate and nitrite)
- Negative hysteresis loop and no pitting noted
- AY101-PIL (high nitrate, low nitrite)
- Oxidation of electro-active species noted

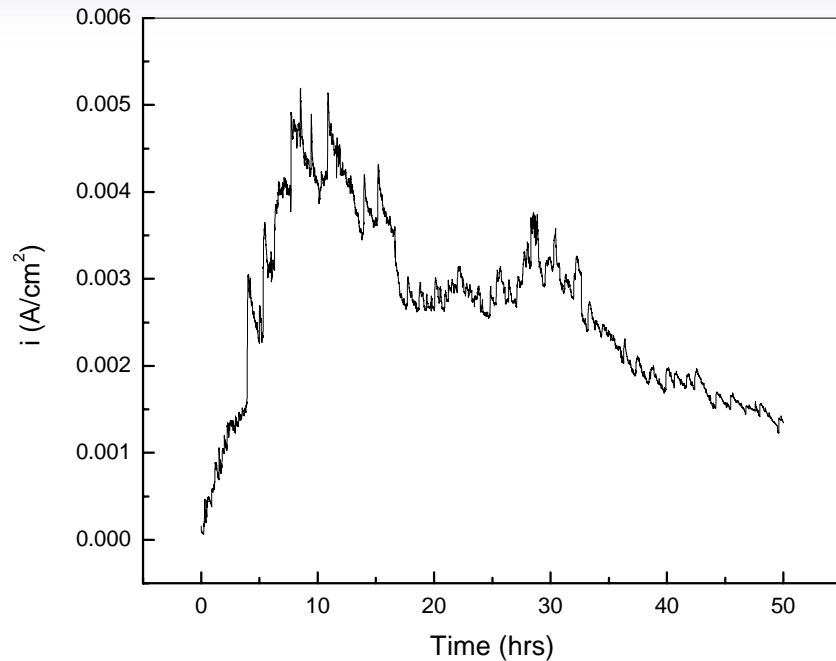
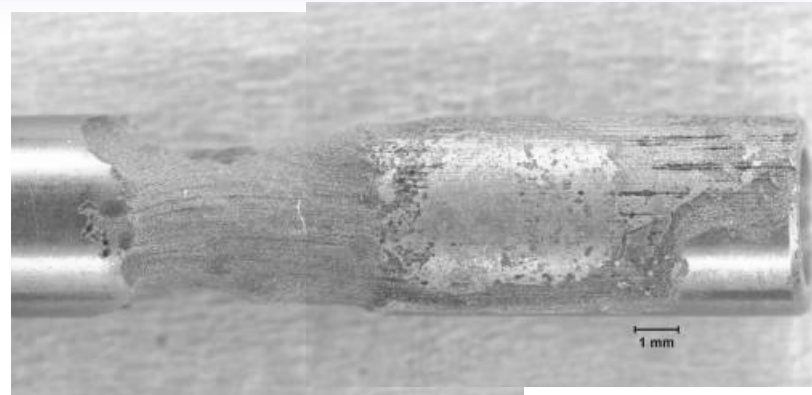
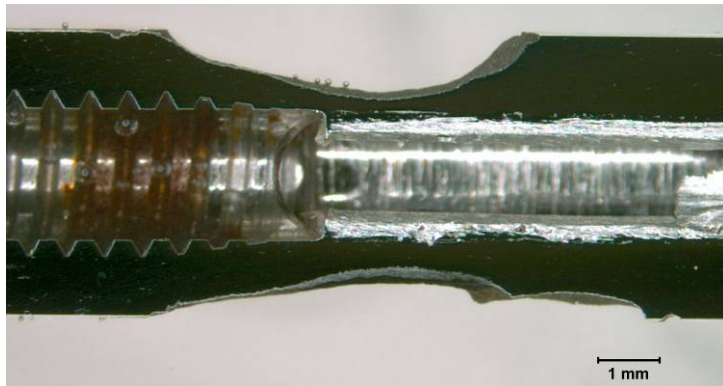
AP105-PSC: interface corrosion

- Corrosion attack at the solution/vapor interface observed after 50 hours of potentiostatic hold at 0 mV vs. SCE (50°C)
- Investigation in progress

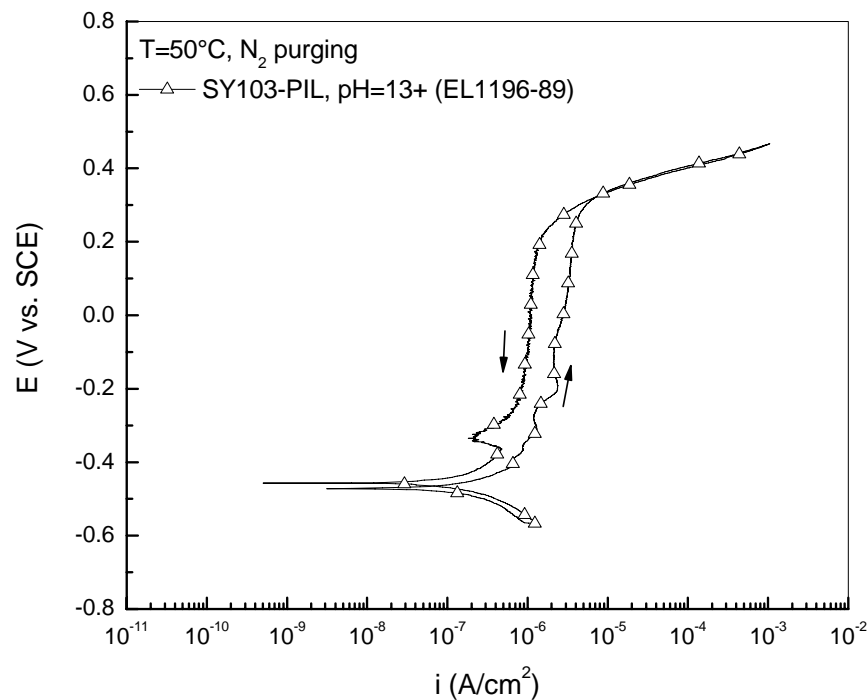
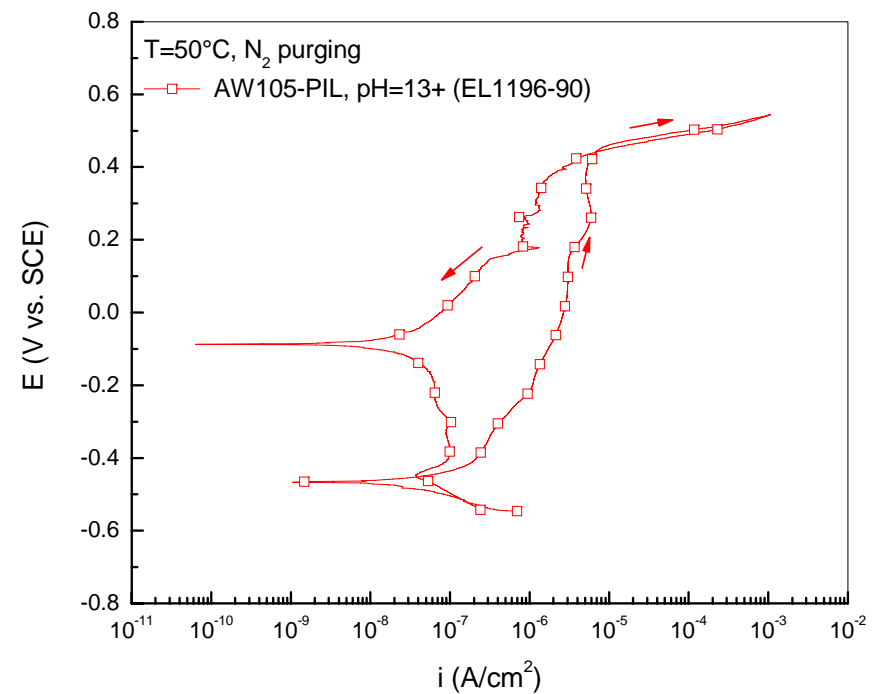
CPP of SY103-PIL and AW105-PIL

- No pitting corrosion was observed in either SY103 or AW105 simulants
- The nitrite and other inhibiting chemicals seemed to be able to provide inhibition against high chloride and fluoride levels ($\sim 0.5\text{M}$);

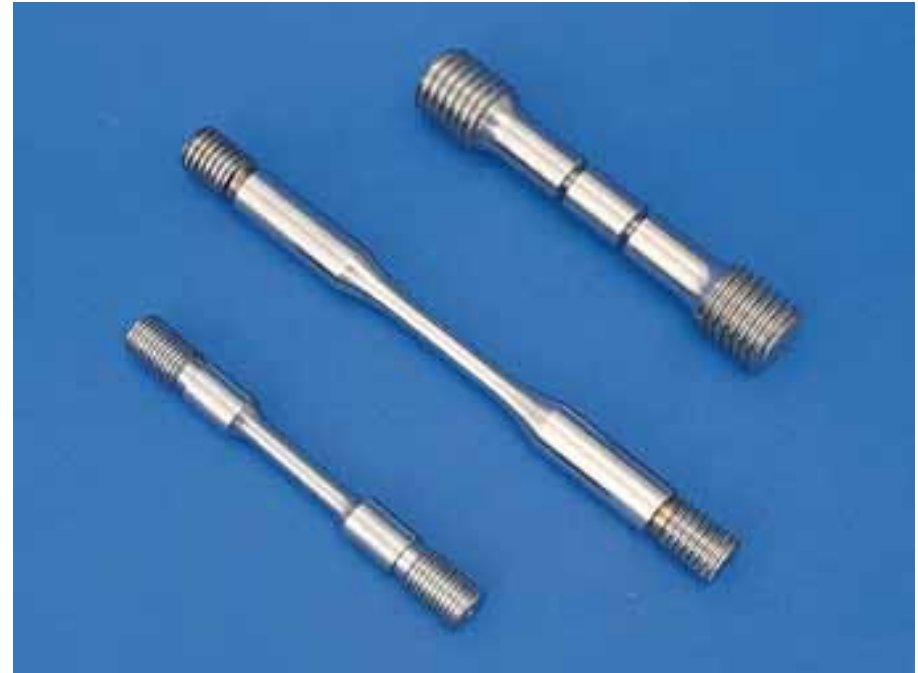
Basic SSRT Set-up

- Uniaxial tension test
- Specimen is immersed in test solution
- Potential controlled
- Temperature controlled
- Strain rate 10^{-6} /s
- Strain to failure
- Fracture surface examined visually/stereo/SEM

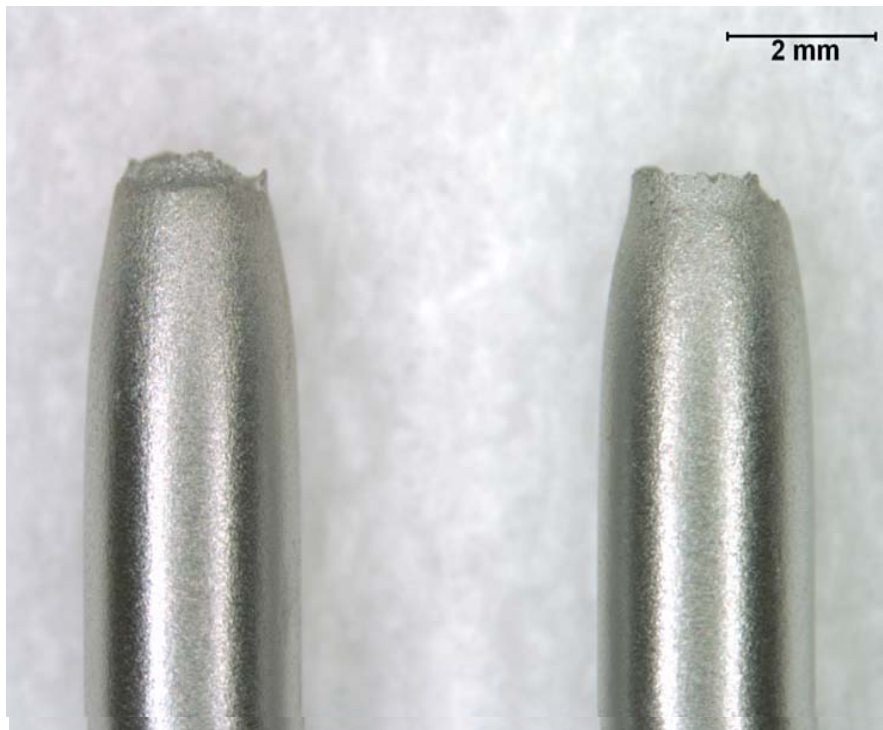
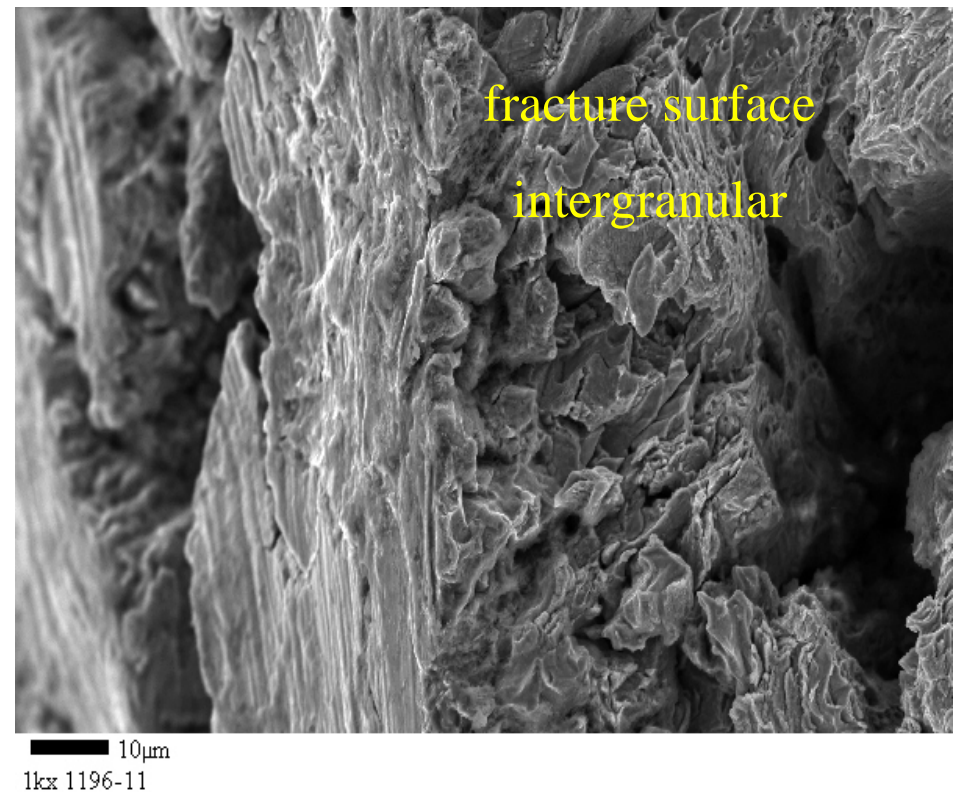
SSRT in AY102-PIL (carbonate)

- Test at OCP (-330 mV vs SCE)
- Comparable to service
- Test at -800 mV vs SCE
- Unlikely in service

- Simulants generally benign with respect to SCC at OCP
- SCC observed in nitrate base simulants when anodically polarized to 0 mV vs SCE
- SCC observed in carbonate based simulant at -800 mV vs SCE
- Previous nitrite/nitrate vs potential trend appears valid
- Interfacial corrosion observed in AP105-PSC test, investigation in progress.

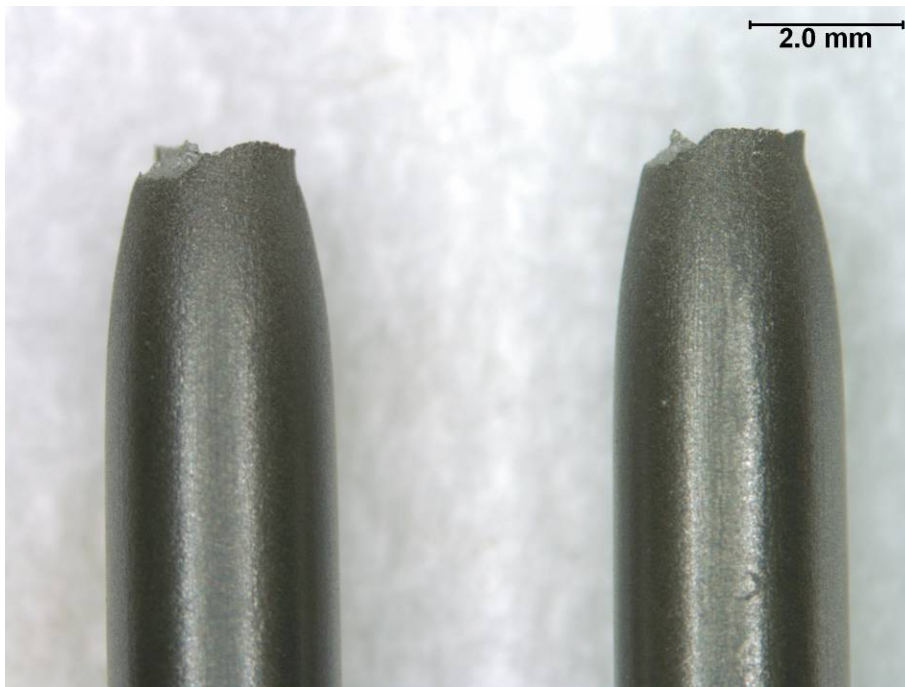
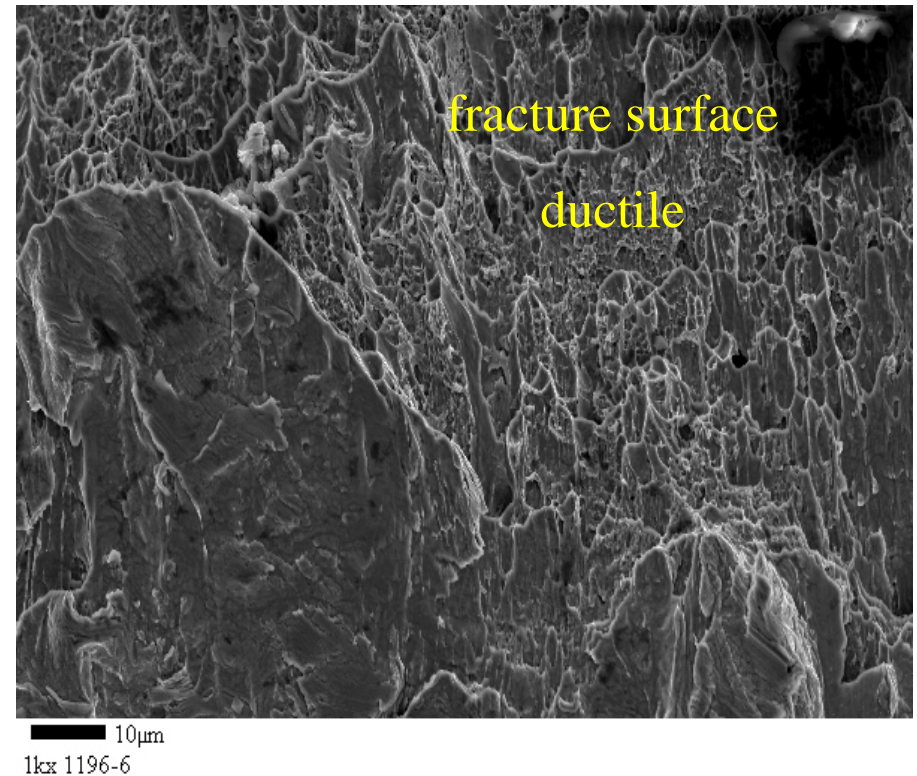
SSRT in AP101-TSC (nitrite/nitrate)

- Test at OCP (-448 mV vs SCE)
- Comparable to service
- Test at 0 mV vs SCE
- Unlikely in service

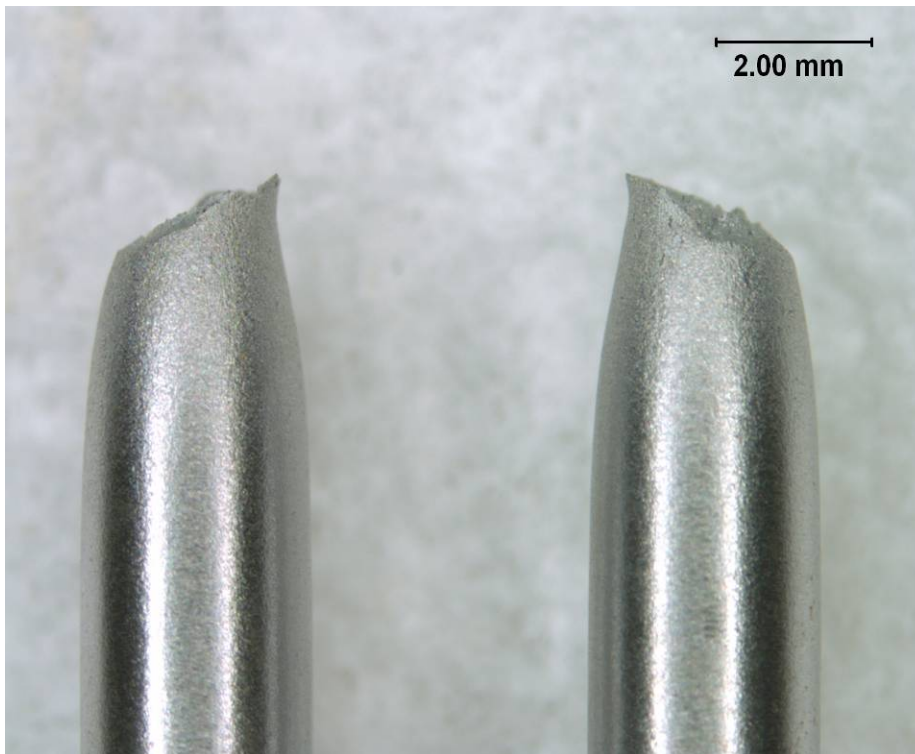
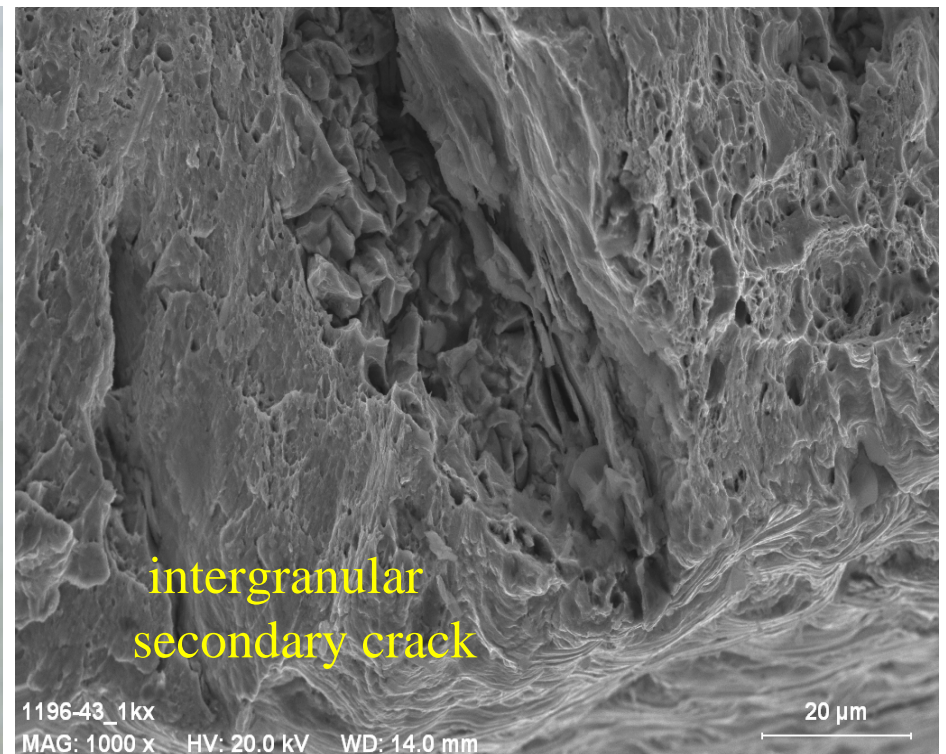
SSRT in AY101-PSC (nitrate)

- Test at OCP (-242 mV vs SCE)
- Comparable to service
- Test at 0 mV vs SCE
- Unlikely in service

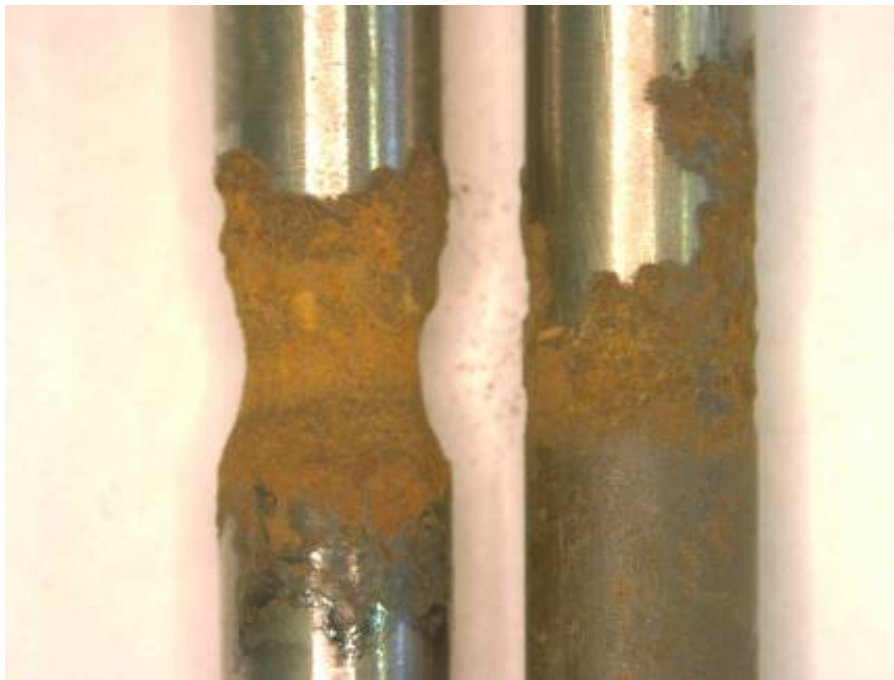
SSRT in AP105-PSC at 0 mV vs SCE

■ Stereo-microscopy of interface

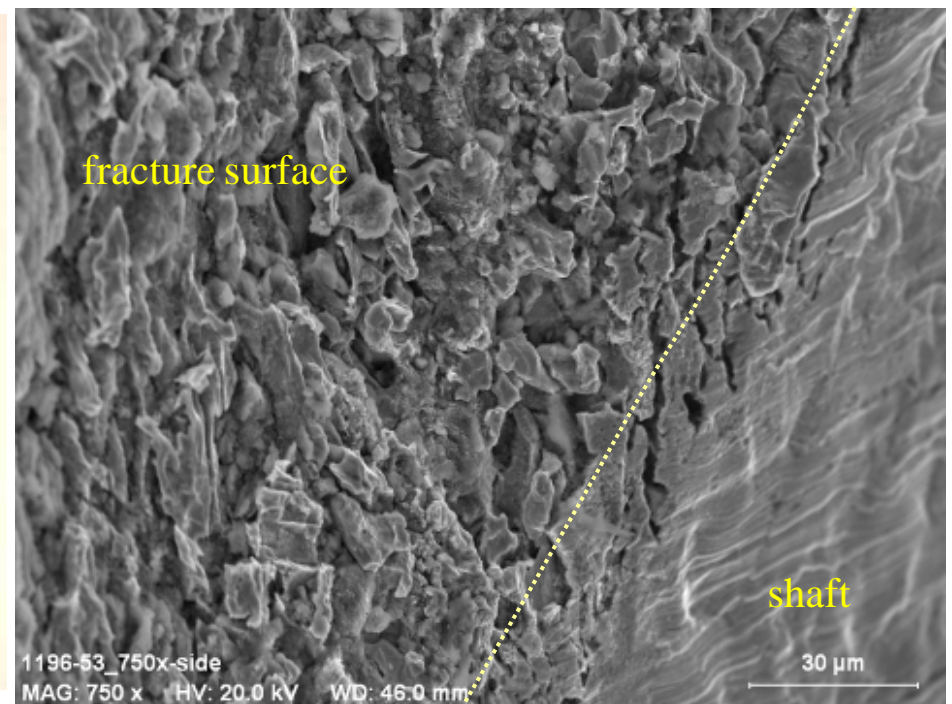
■ Fracture surface SEM exam

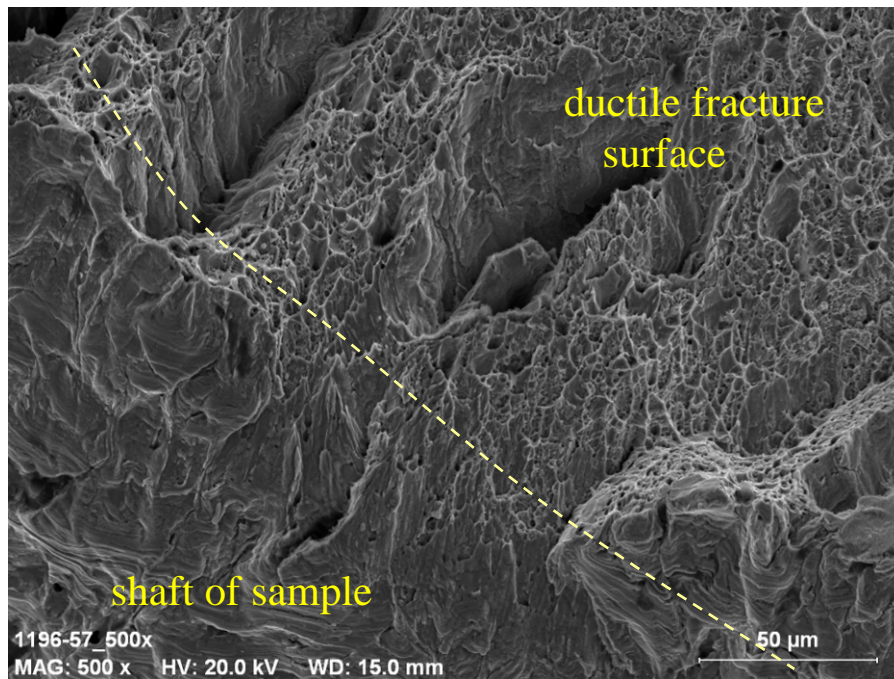
■ SY103 at 0 mV vs SCE

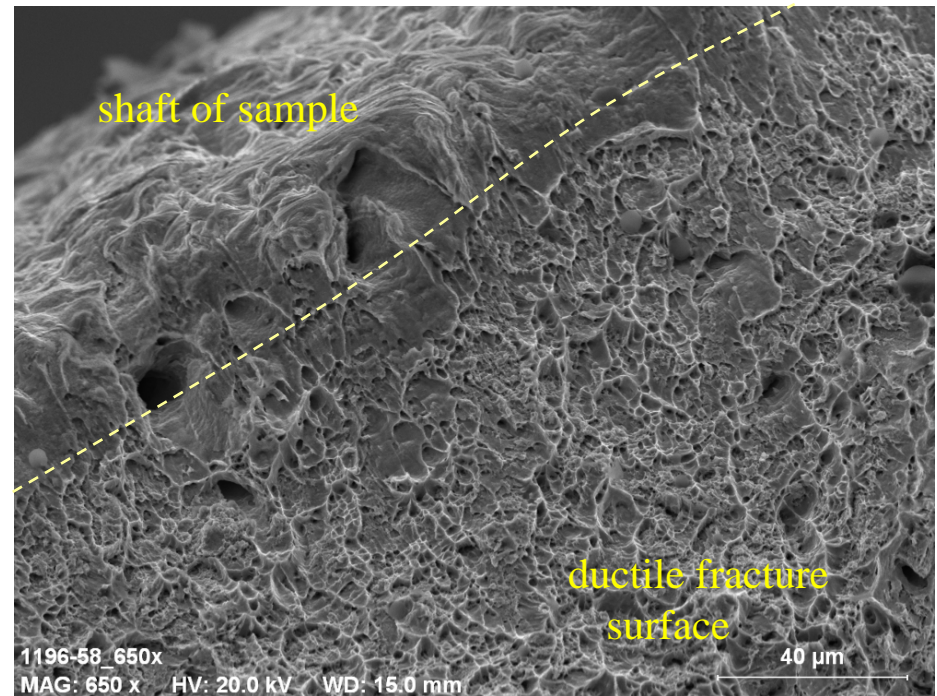
■ AW105 at 0 mV vs SCE

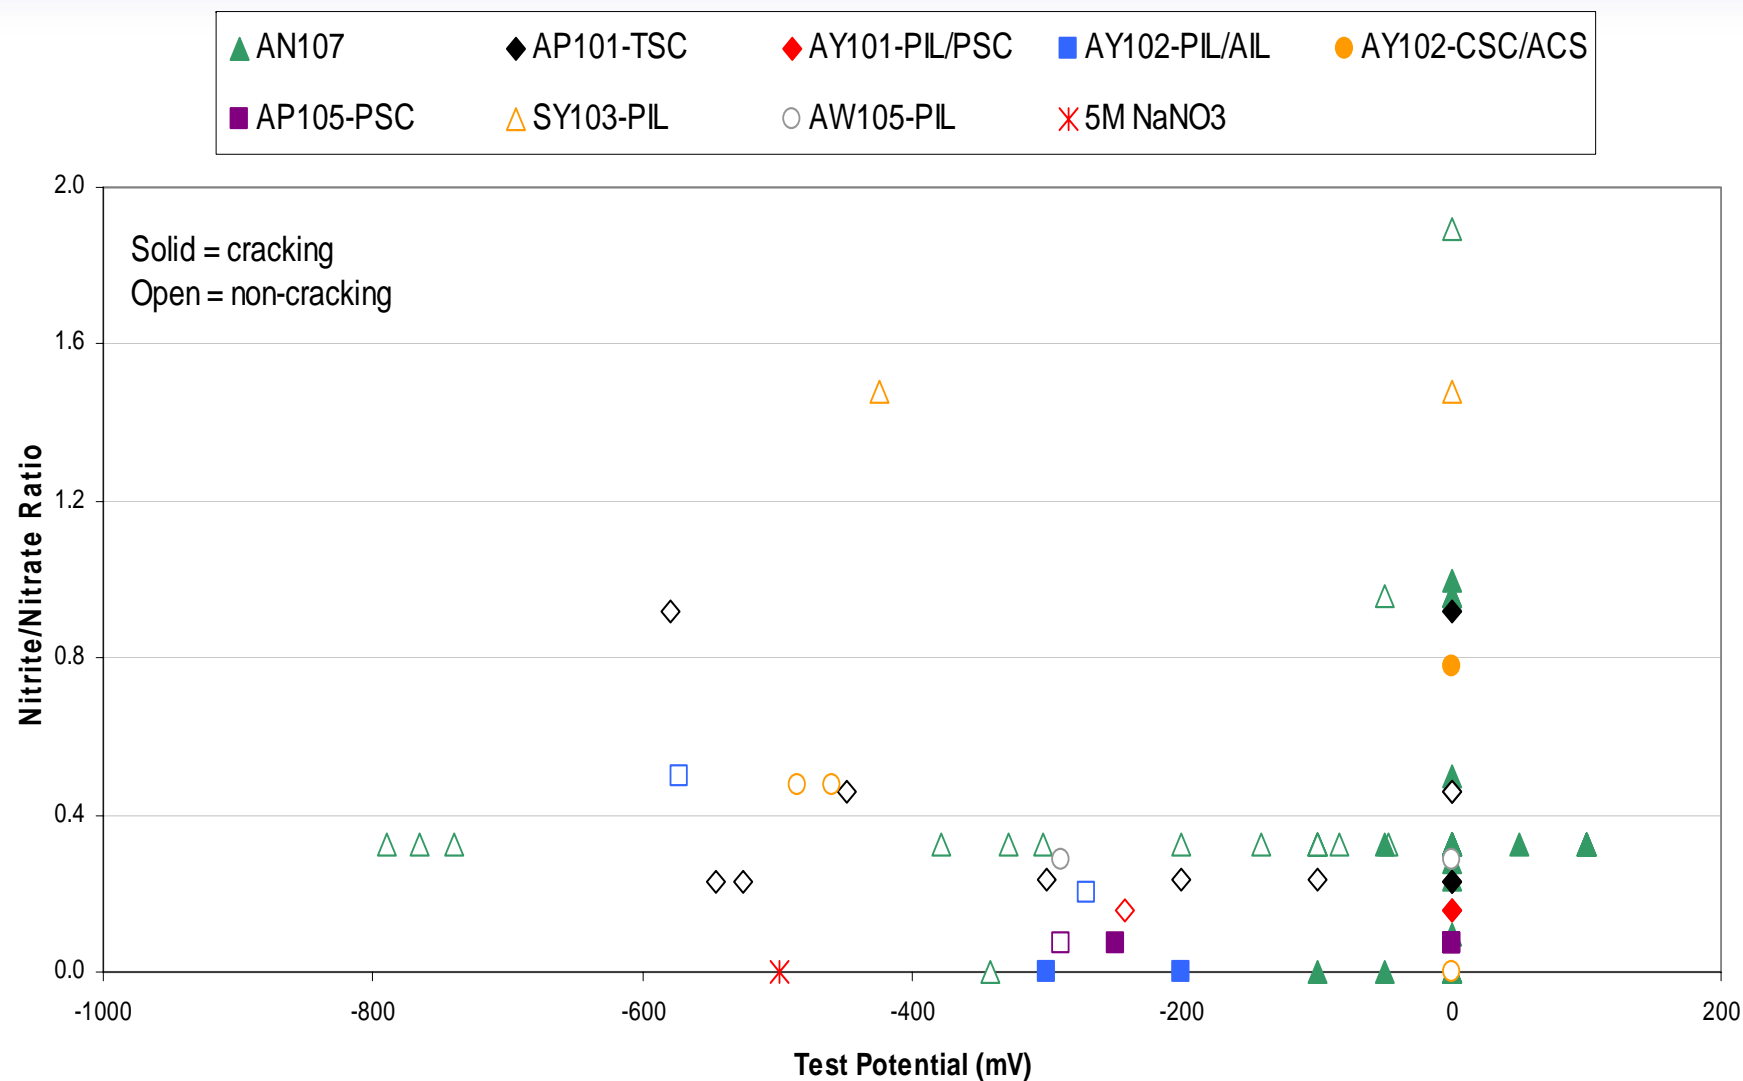
Plot of Nitrite/Nitrate Ratio vs Potential

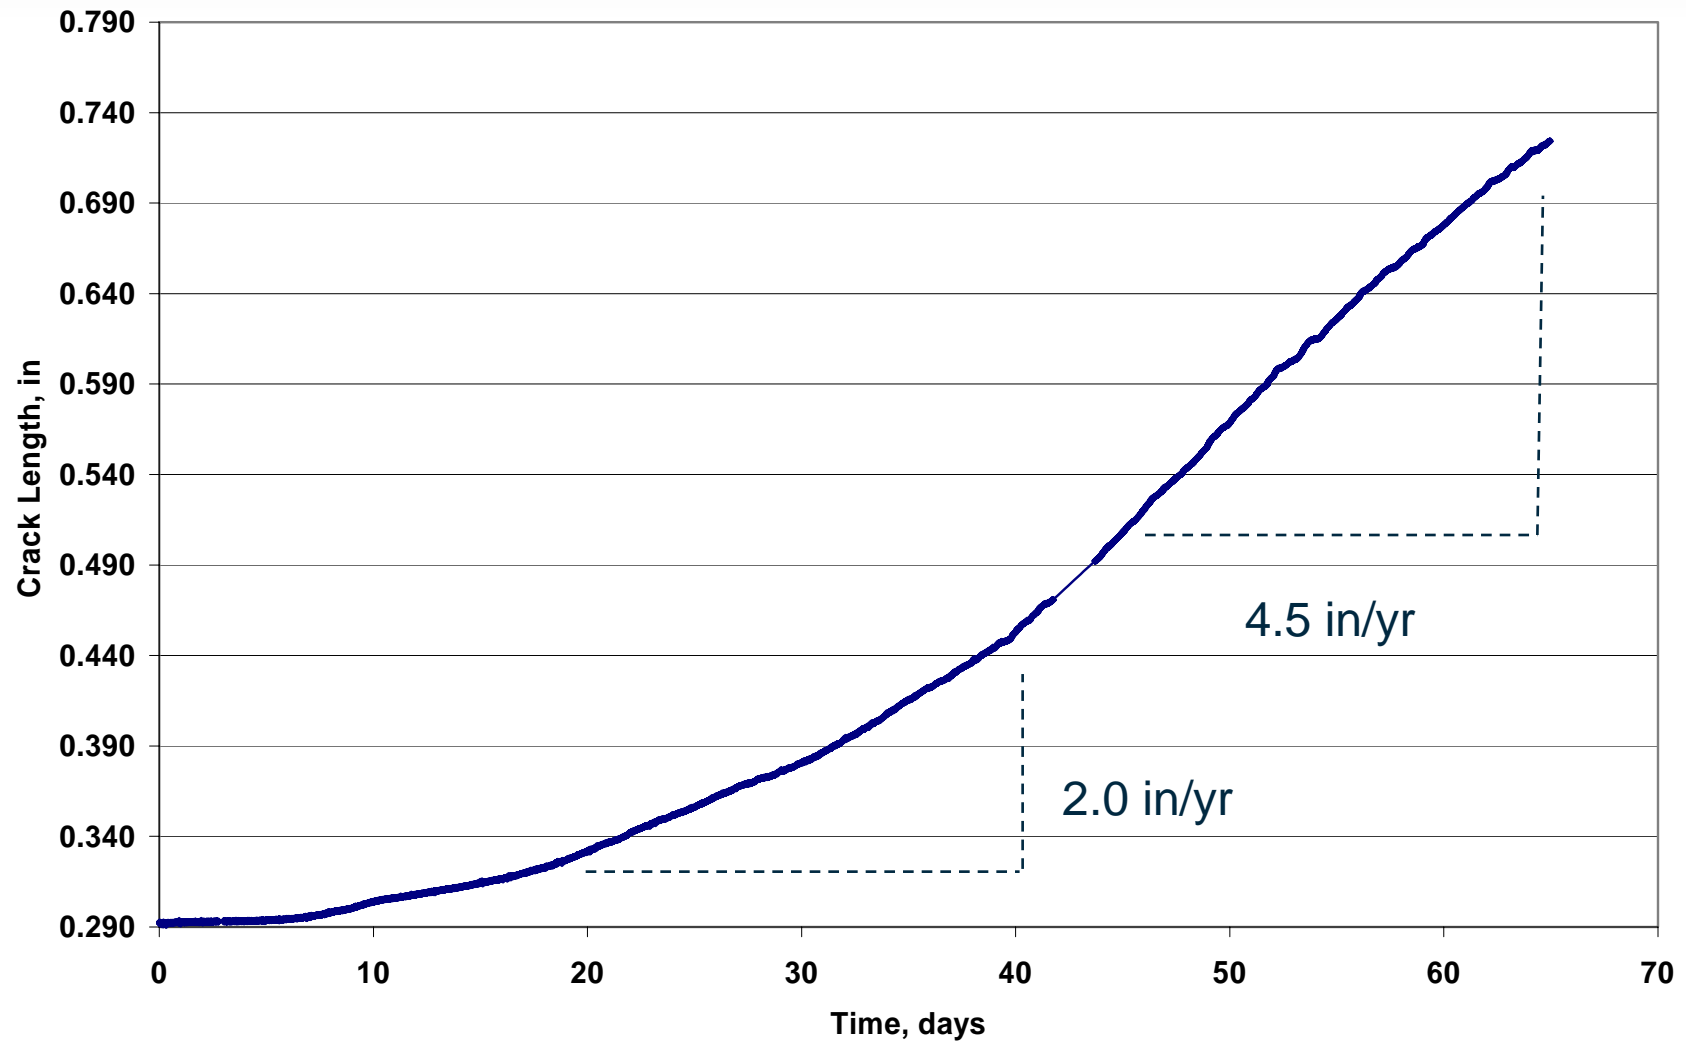
- 5M NaNO₃ solution
 - Monitor load and DCPD crack length
 - Loaded to ensure cracking
 - Hold for long term (4-6 months?) at constant displacement
 - In progress –significant cracking
- AY101-PSC simulant
 - Monitor load and DCPD crack length
 - Loaded to 45 ksi√in
 - Hold for long term (4-6 months?) at constant displacement
 - In progress – possible minor cracking
